ATTACHMENT E

Site Location
Victorville PBR No.1
 FUDS Project No. J09CA067501
 San Bernardino County, California

**Site Setting and MRS Designation
Victorville PBR No.1**

FUDS Project No. J09CA067501

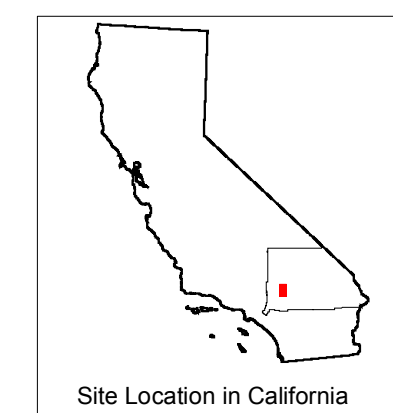
Figure 1.2

- Range Boundary
- - - Project Boundary

The Victorville PBR No. 1 site consists of one MRS, totaling 649 acres (CEMVR, 2004), which corresponds to the area depicted on Figure 1.2. The one MRS (listed below) is currently owned by numerous landowners, with a Wal-Mart Distribution Center located on the northern portion of the site. The risk assessment code (RAC) score for this site range was a 3 in the ASR Supplement, indicating a moderate hazard range potential.

- **MRS 01 – Practice Bomb Target** – This area originally consisted of approximately 560 acres of undeveloped and sparsely vegetated desert land used by VAAF as a precision bombing range for training pilots stationed at VAAF (refer to Figure A below). There have been no reports of MEC in this MRS. In support of the 1994 INPR, a site visit was conducted on 7 December 1988 where the team observed MD spaced 15 to 20 feet apart within the target circles and 75 to 100 feet apart in the remainder of the site. The site visit conducted from 16 to 19 April 1996 in support of the ASR found a twisted and half-buried rear portion of an M38A2 100-lb sand-filled practice bomb and a spotting charge used in the M38A2 practice bomb. The ASR Supplement reported a RAC score of 3 for this MRS with a Hazard Severity Value of “marginal” based on the potential residual presence of practice bombs (with spotting charges), and a Hazard Probability of “probable” based on the potential for residual hazards on the surface, the presence of inhabited buildings less than 1,250 feet from the potential hazard, and the lack of a barrier system denying access (CEMVR, 2004).
