Ordinance Investigative Services Report

SkyView – Lafayette Street
Apple Valley, California
Project No: 2141.01

RE: Ordnance Investigative Services Report
SkyView – Lafayette Street
Apple Valley, California
Project No: 2141.01

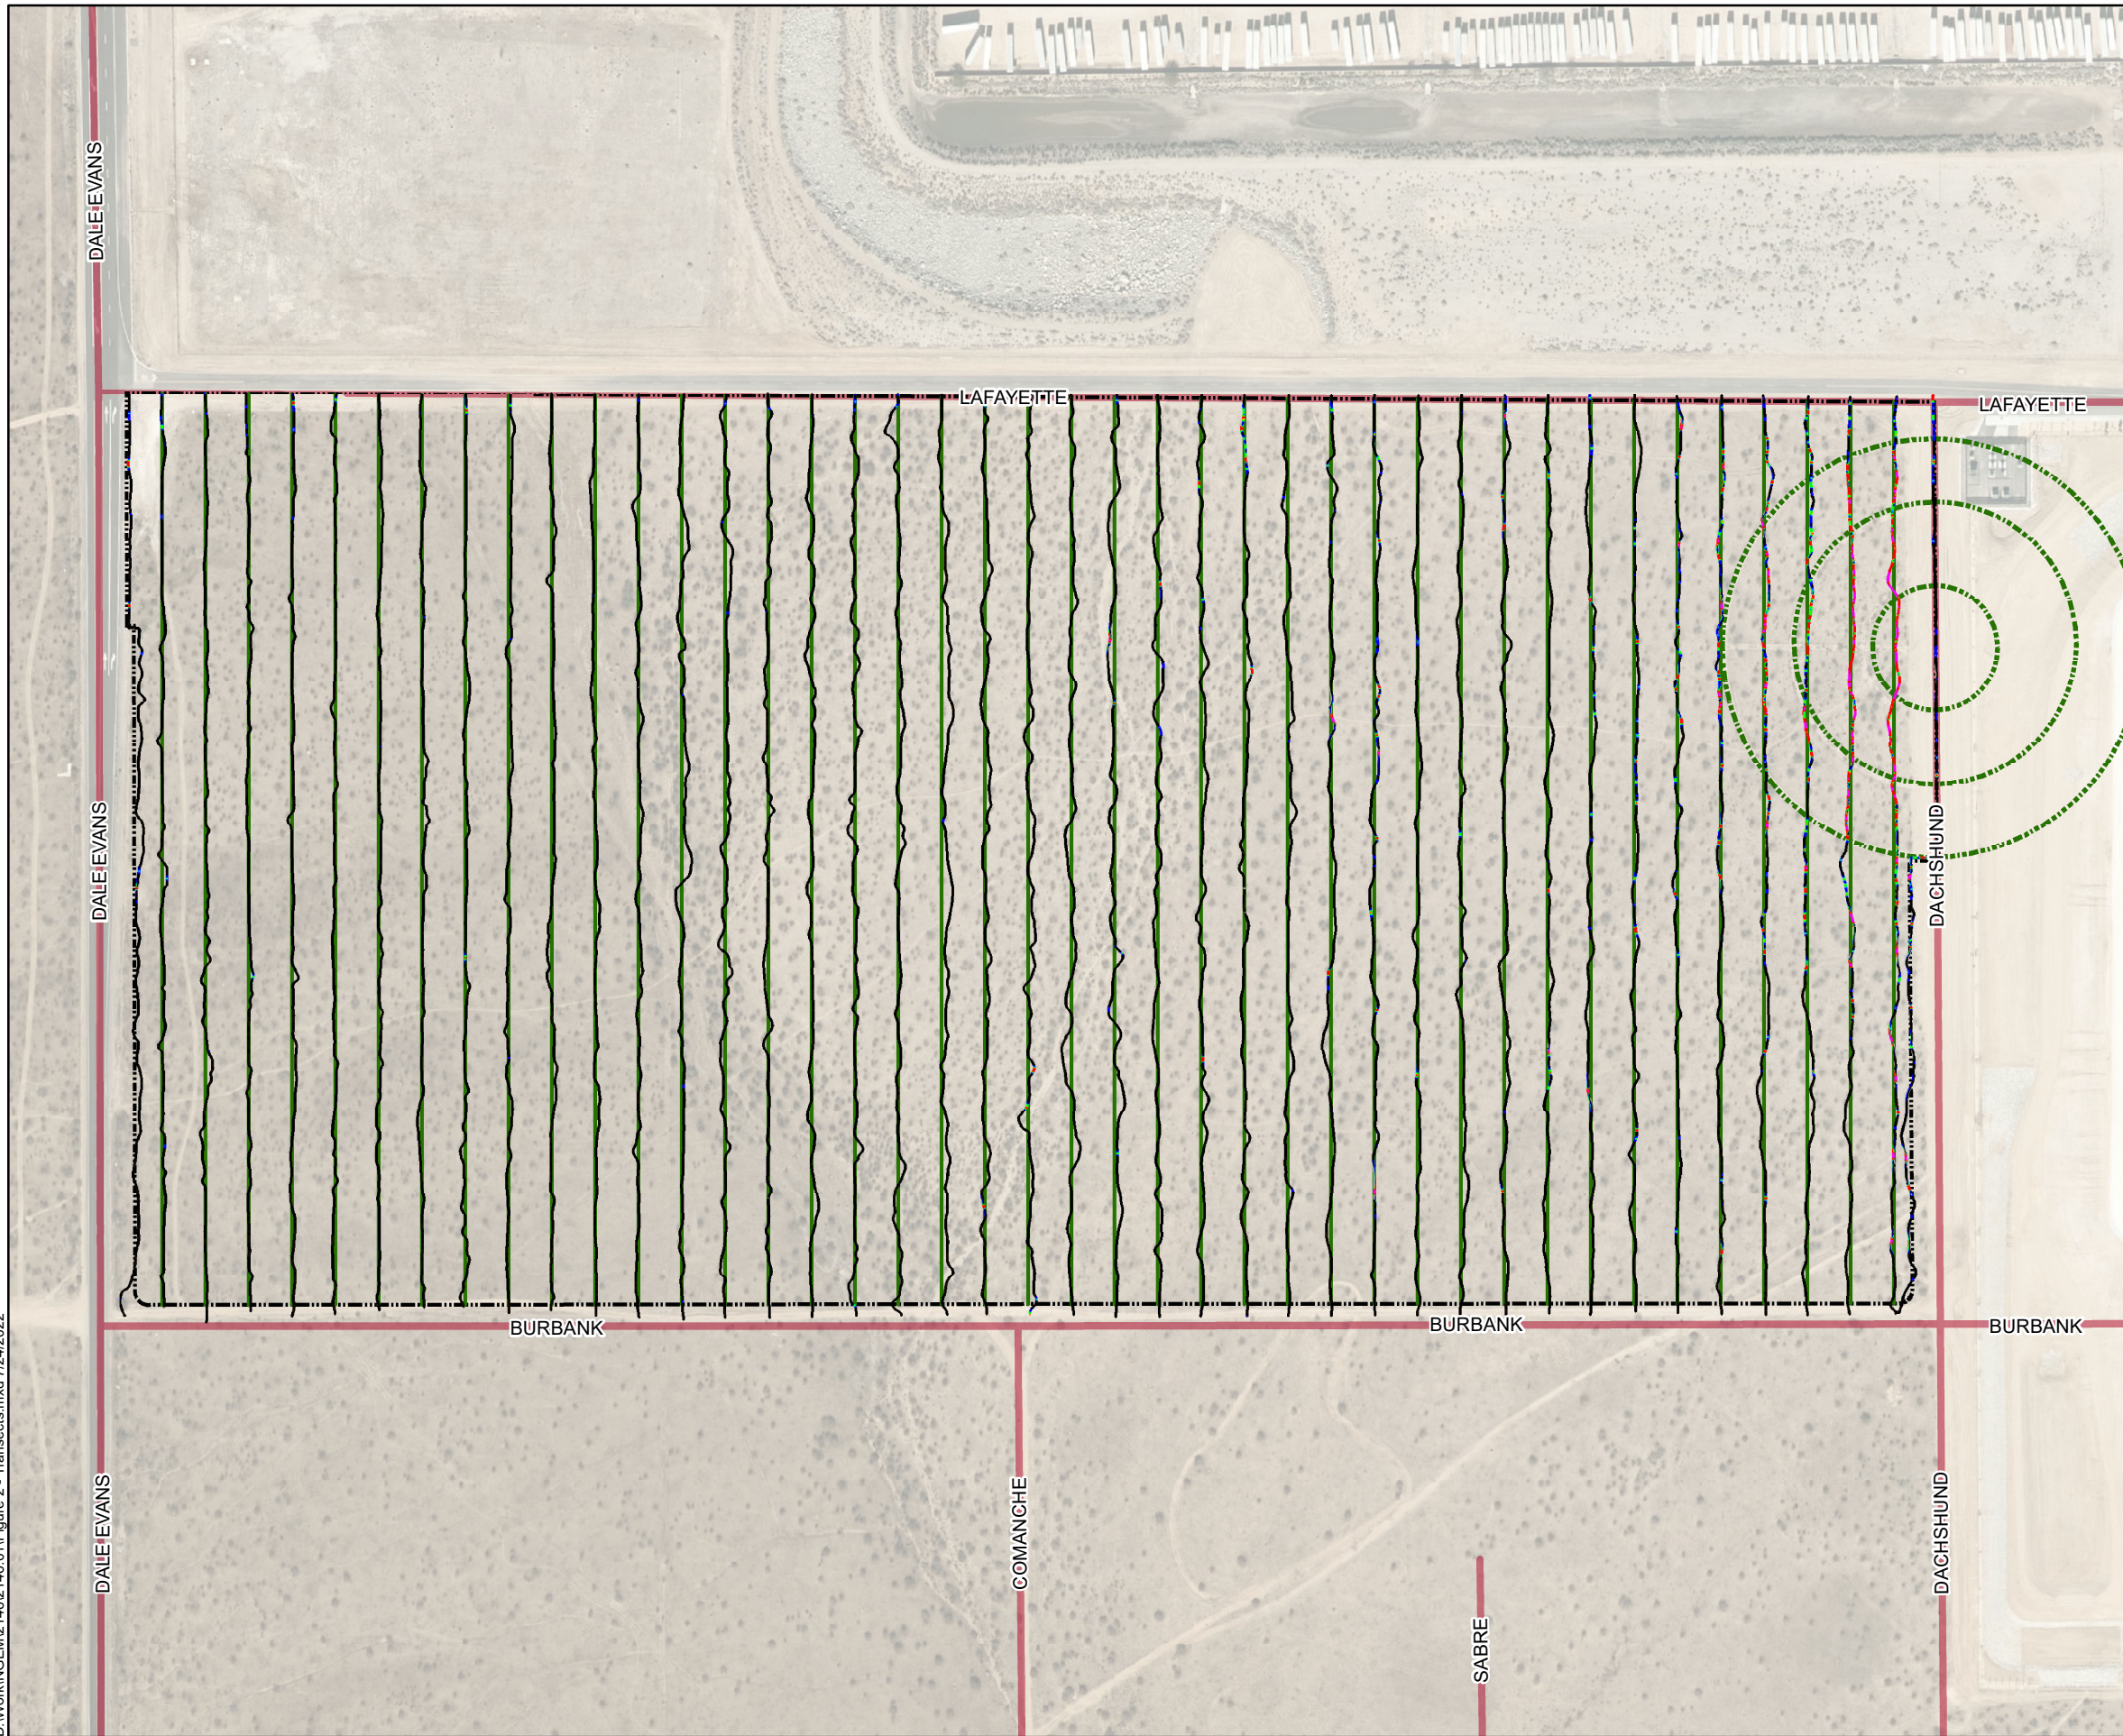
FIGURE 2
Survey Transects

during mapping with the survey data. The survey was performed in 41 transects taken in a north-south direction to generate 10.8 miles of transect data. The transects were approximately 60 feet apart as shown on Figure 2. The transect alignments vary from a straight line due to the equipment moving laterally to avoid vegetation or other obstructions during mapping. A statistical kriging model was employed to interpolate the estimated number of anomalies in between the transects.

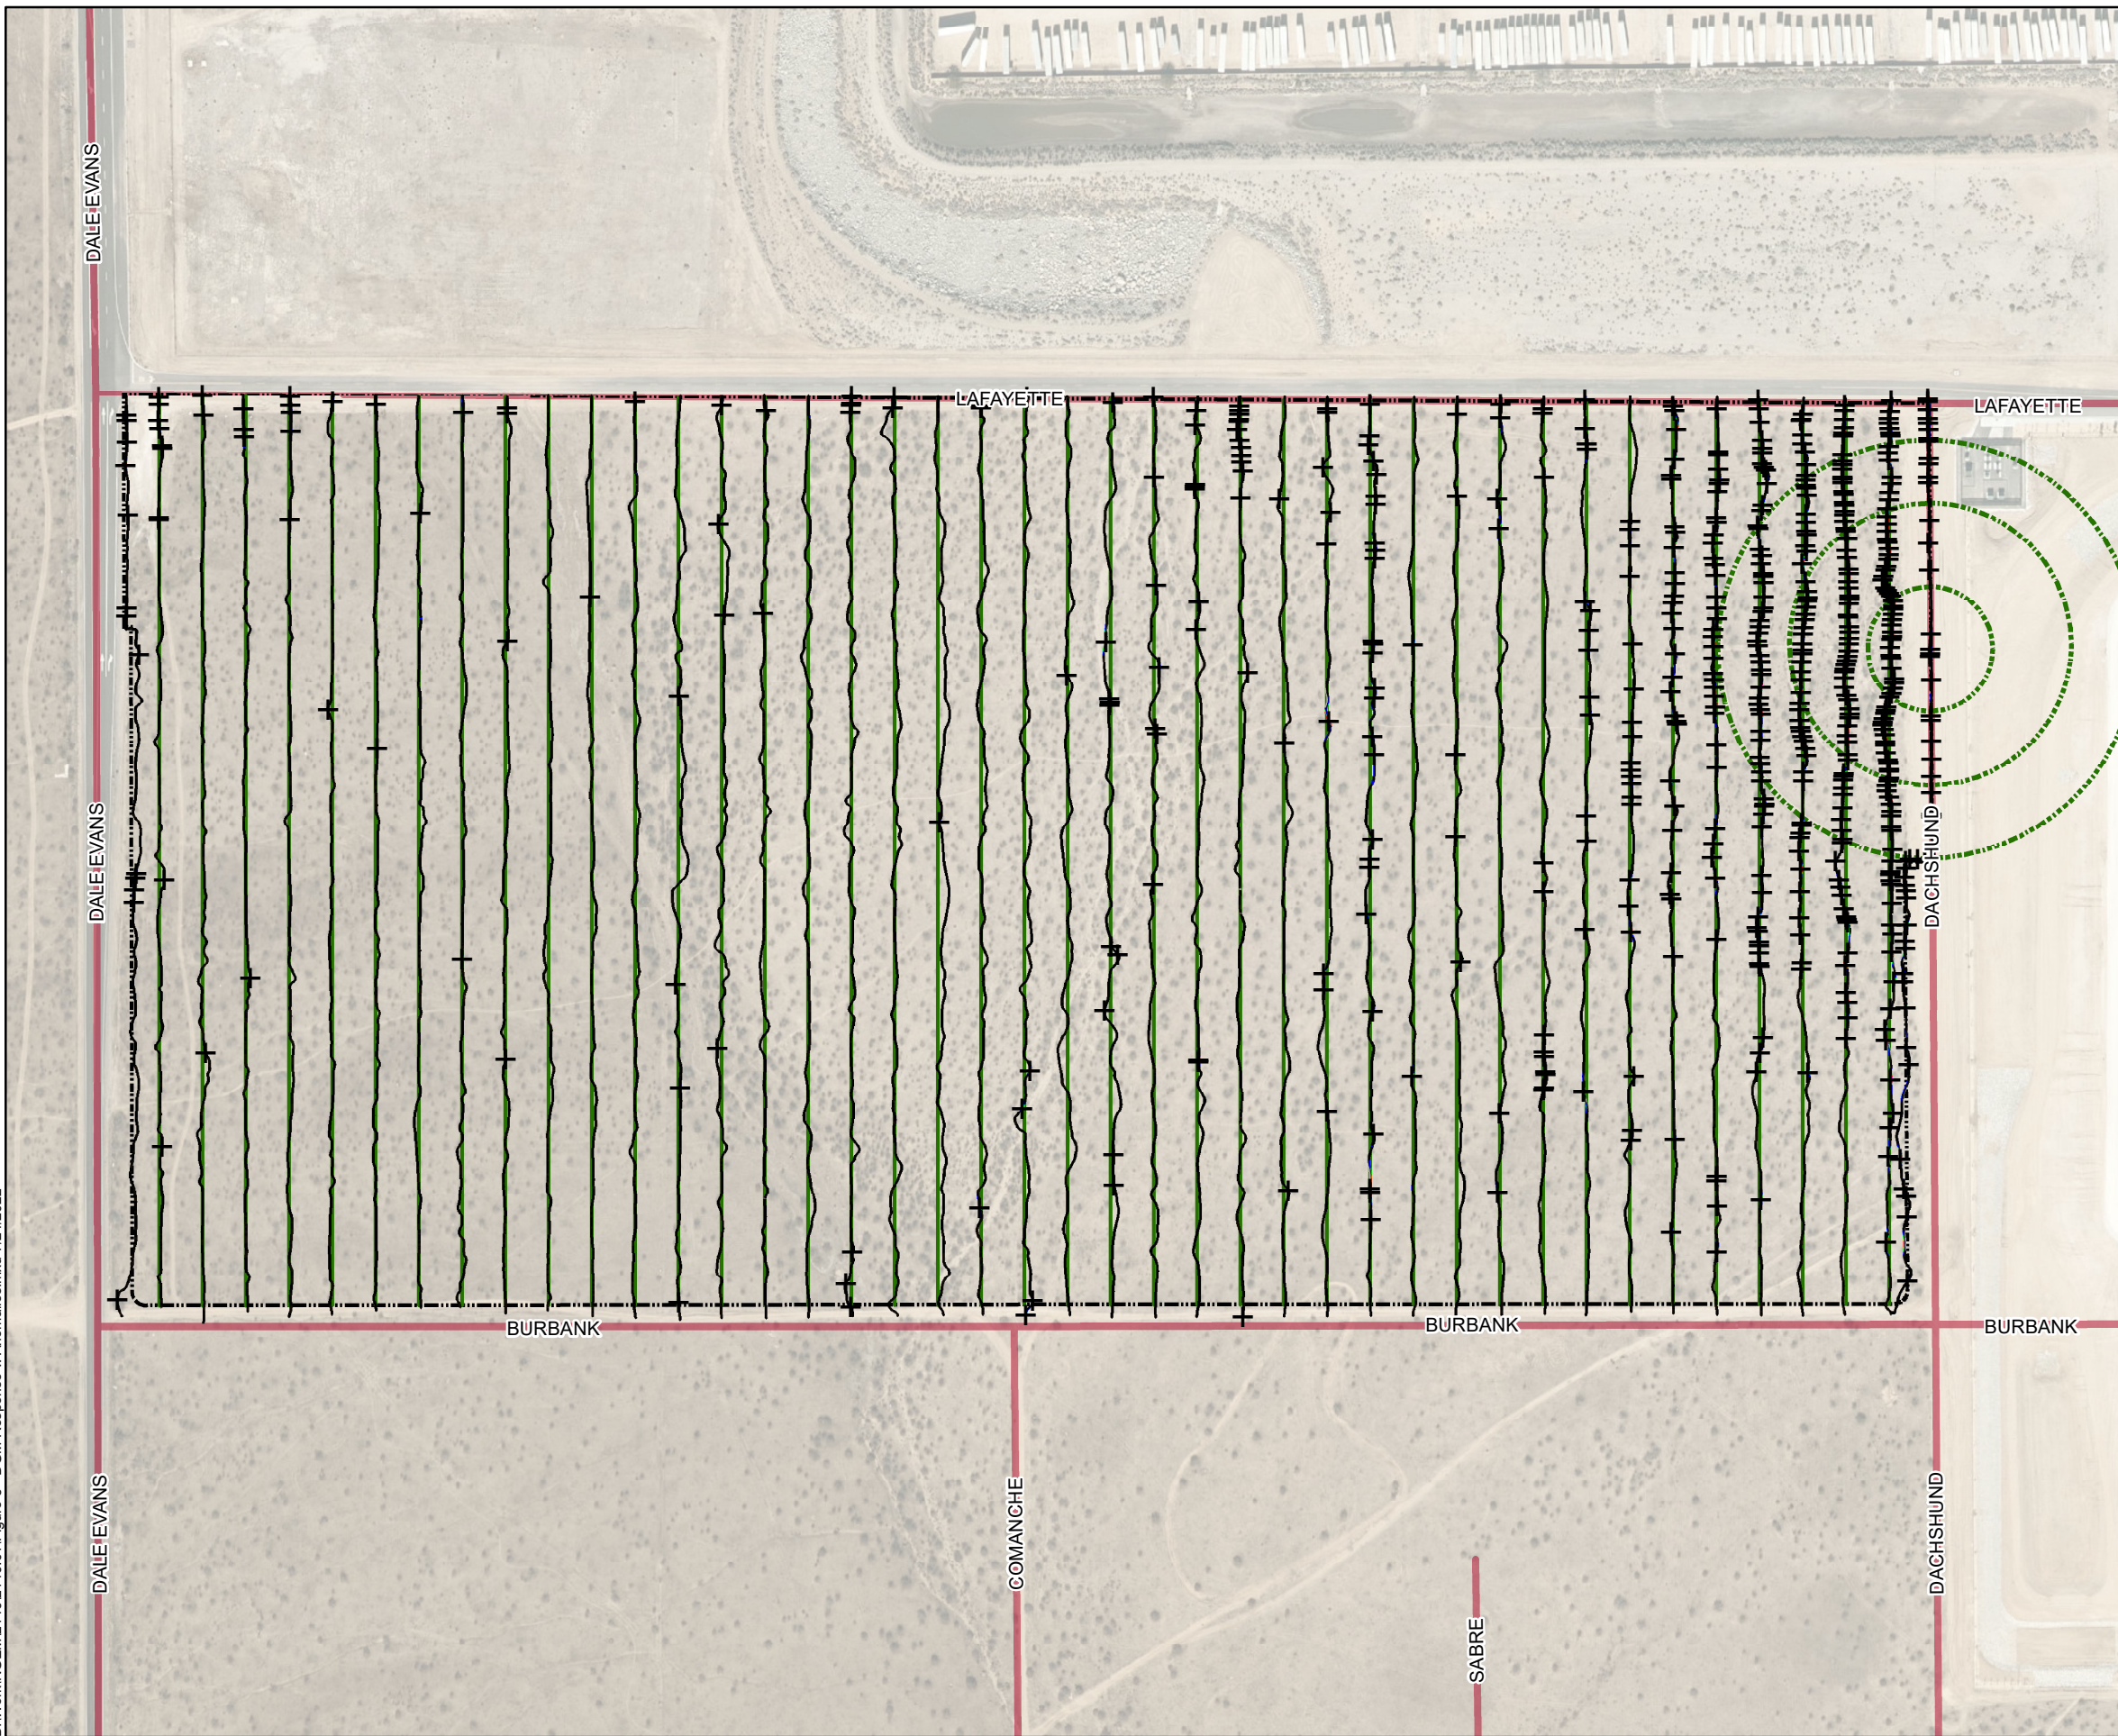
FIGURE 3
DGM Response with Anomalies

The geophysical survey was performed in accordance with the Northgate's proposal dated April 19, 2022. The survey was successful in identifying the location and estimated density of surface and buried metal at the transect locations. The 10.8 miles of transect resulted in 626 detected anomalies as shown in Figure 3. A total of 382 anomalies were detected within roughly 250 feet of the target. The results of the kriged data model identified a high-density area, denoted by a gray line, around the target area where 810 anomalies per acre were predicted as shown on Figure 4.

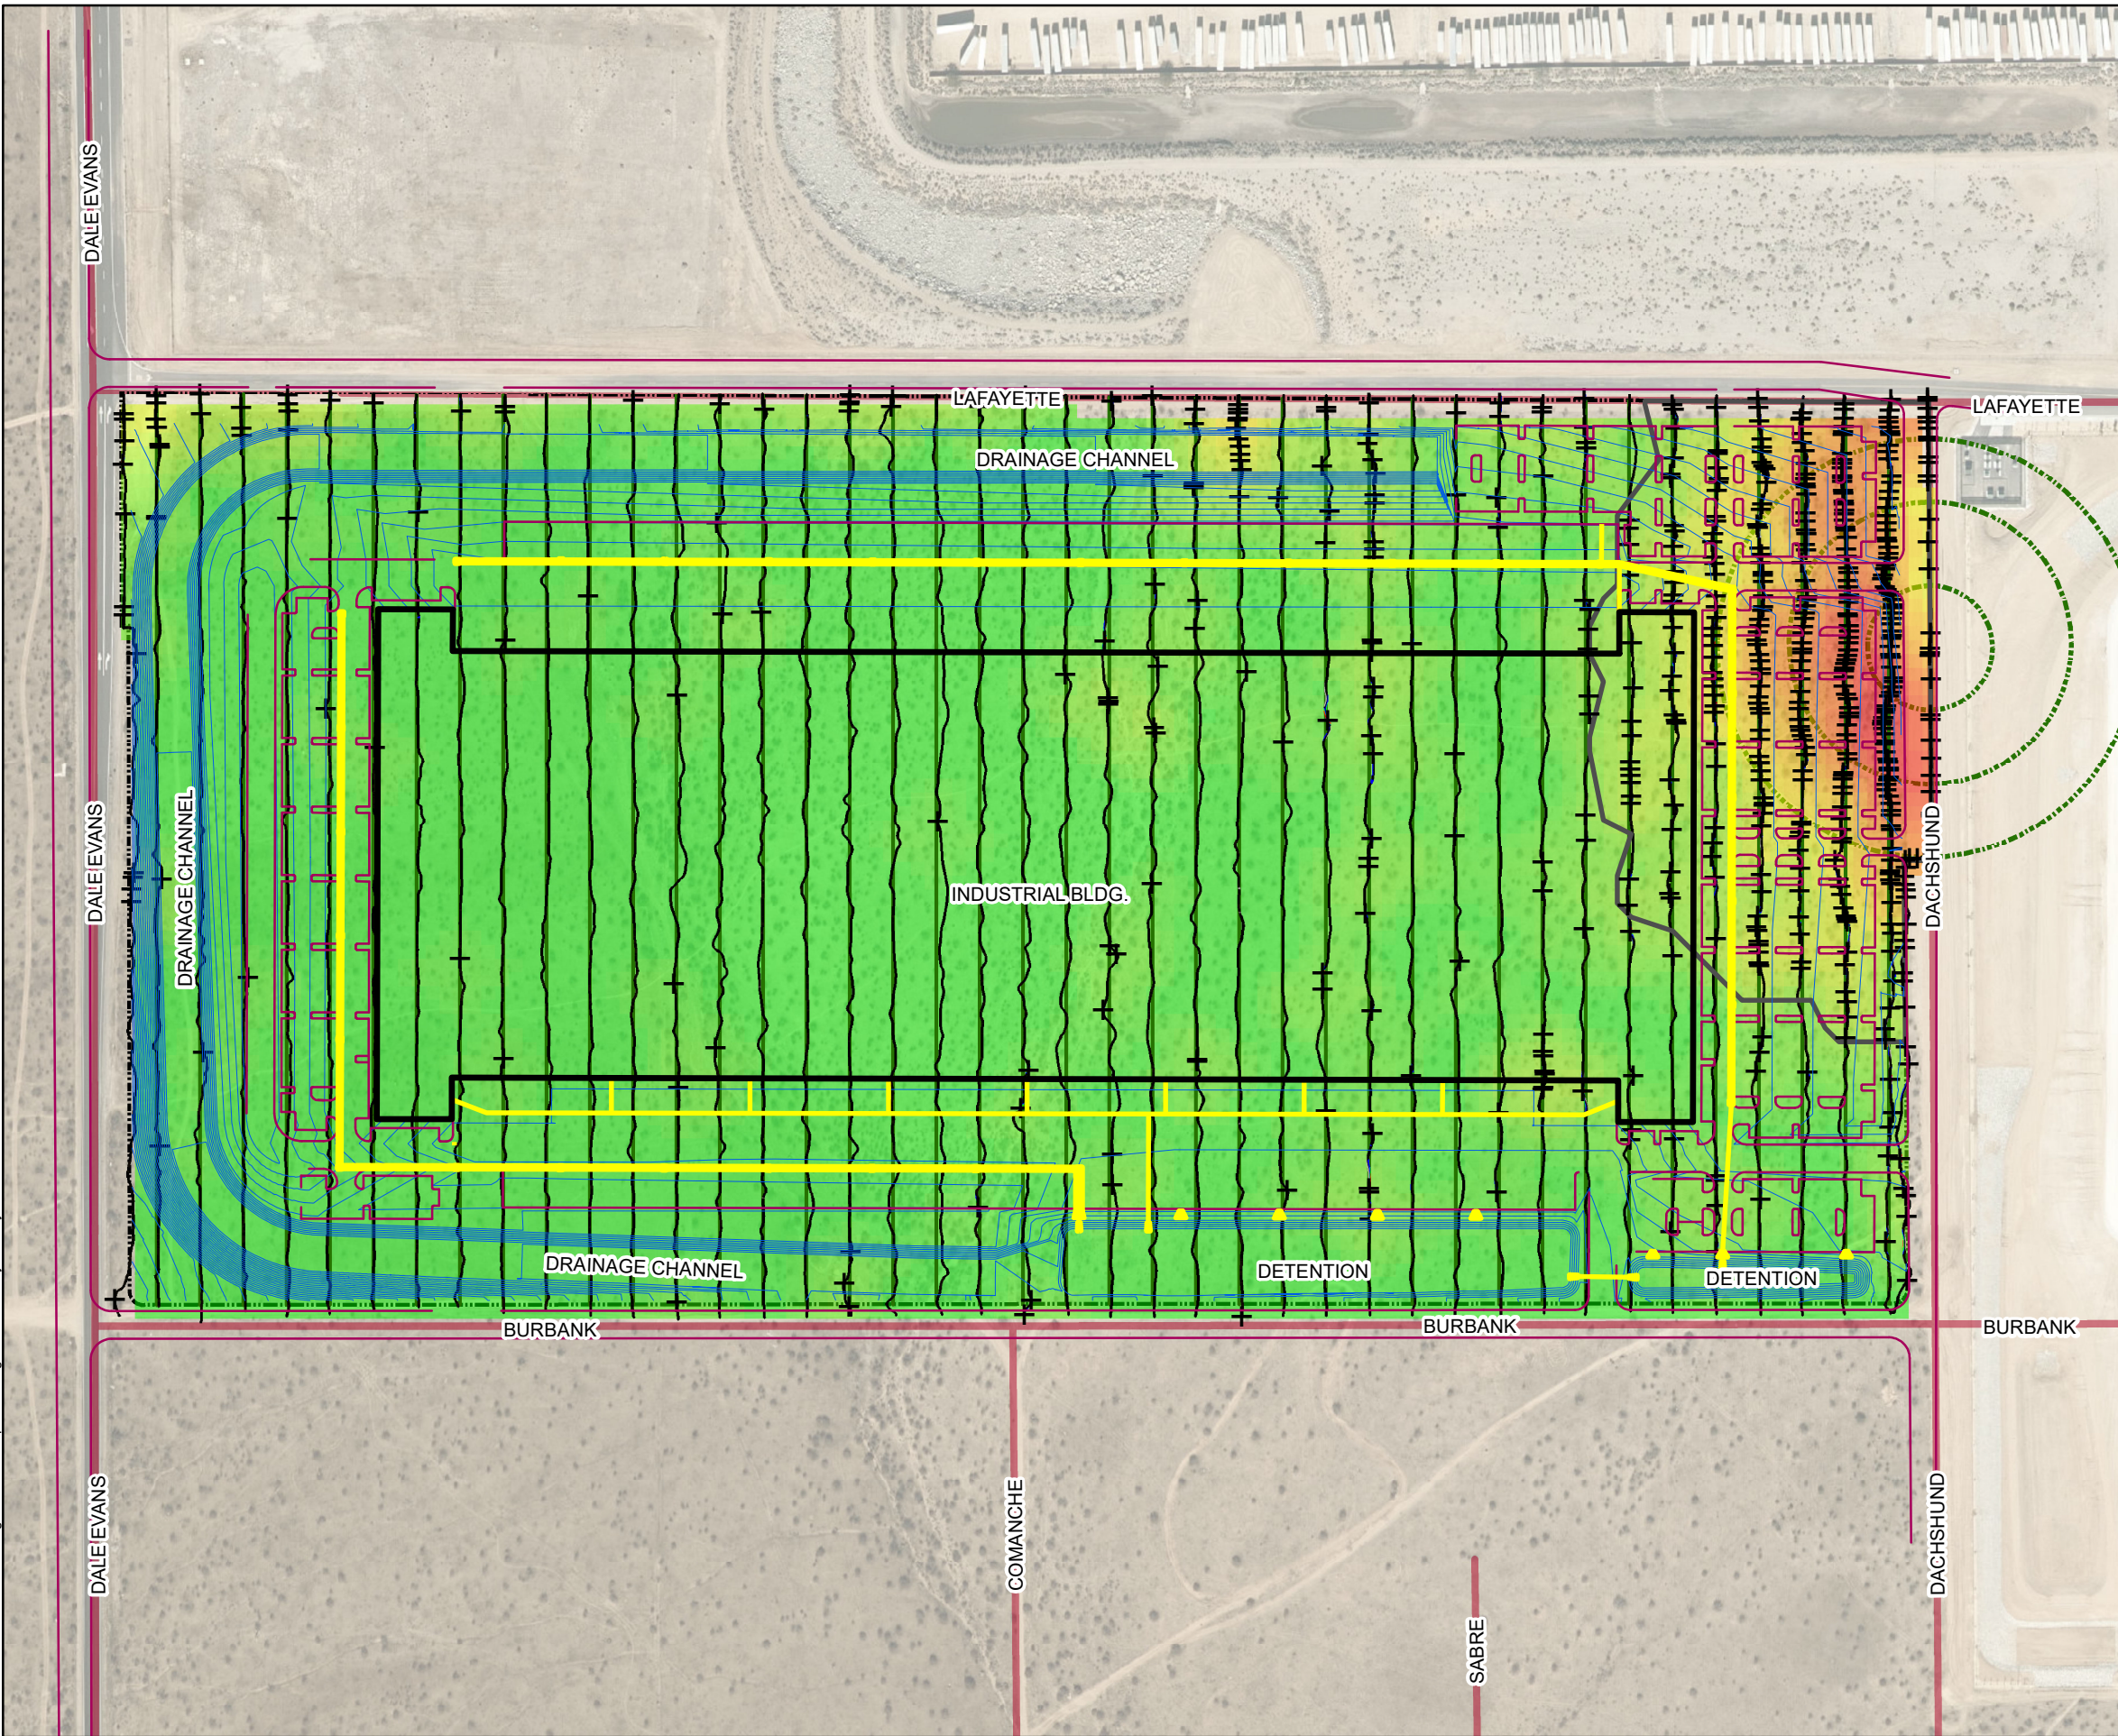
FIGURE 5
Conceptual Building Design and Anomaly Density

Figure 5 shows the proposed development overlain on the digital geophysical map. The results of the geophysical survey indicate that the high anomaly density area will be developed as parking, and a corner of the proposed building. In addition, an underground storm-drain line will be installed just east of the building wall. This area is proposed to be cut to reach final pad and parking lot elevation.

- Intrusive work in the target/high density area for stormwater transfer line and drainage (after clearance) should be performed by excavator or backhoe equipment and the construction support technician (Unexploded Ordnance [UXO] Technician) should be present during intrusive excavations;

- In the area(s) where fill will be placed in the target/high density area, the fill should be a minimum of 2 feet thick;
- Avoid coming in contact with ordnance-related metal whenever possible;
