Project No.: **22G197-2**

Subject: **Geotechnical Research and Document Review**
Watson High Desert Logistics- West
NWC Los Padres Road and Navajo Road
Apple Valley, California

Reference: Results of Infiltration Testing, Proposed Industrial Building, NWC Los Padres Road and Navajo Road, Apple Valley, California, prepared for Watson Land Development, by Southern California Geotechnical, Inc. (SCG), SCG Project No. 22G197-1, dated July 1, 2022.

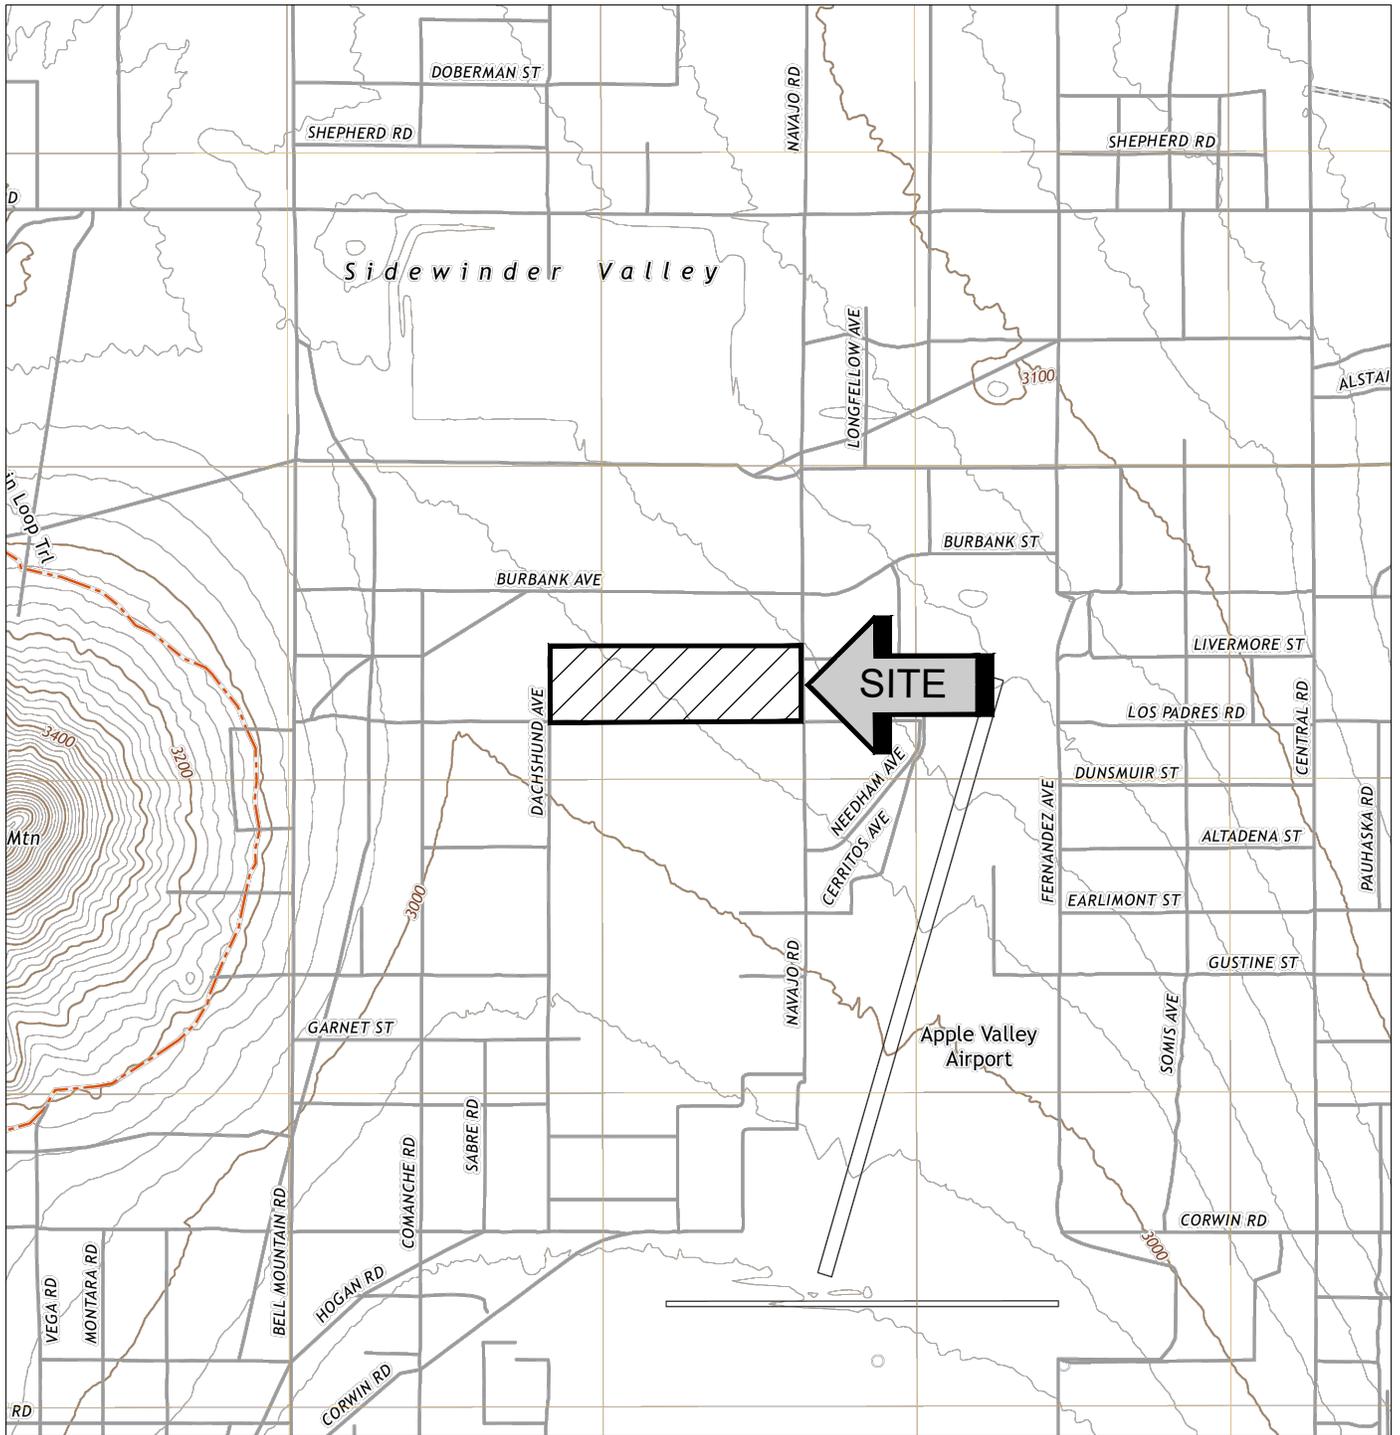
SOUTHERN CALIFORNIA GEOTECHNICAL
DRAWN: MK	
CHKD: DN	
SCG PROJECT 22G197-2	
PLATE 1

SOURCE: USGS TOPOGRAPHIC MAP OF THE APPLE VALLEY
 NORTH QUADRANGLE, SAN BERNARDINO COUNTY,
 CALIFORNIA, 2021.

SITE LOCATION MAP	
PROPOSED INDUSTRIAL BUILDING	
APPLE VALLEY, CALIFORNIA	
SCALE: 1" = 2000'

The subject site is located at the northwest corner of Los Padres Road and Navajo Road in Apple Valley, California. The site is bounded to the north by a Big Lots distribution building, to the west by a vacant lot, to the south by Los Padres Road, and to the east by Navajo Road. The general location of the site is illustrated on the Site Location Map, included as Plate 1 of this report.

Detailed topographic information was not available at the time of this report. Based on visual observations made at the time of the subsurface investigation, as well as the our review of the USGS Topographic map, included as Plate 1 of this report, the overall site slopes to the southwest at a gradient of 1± percent.

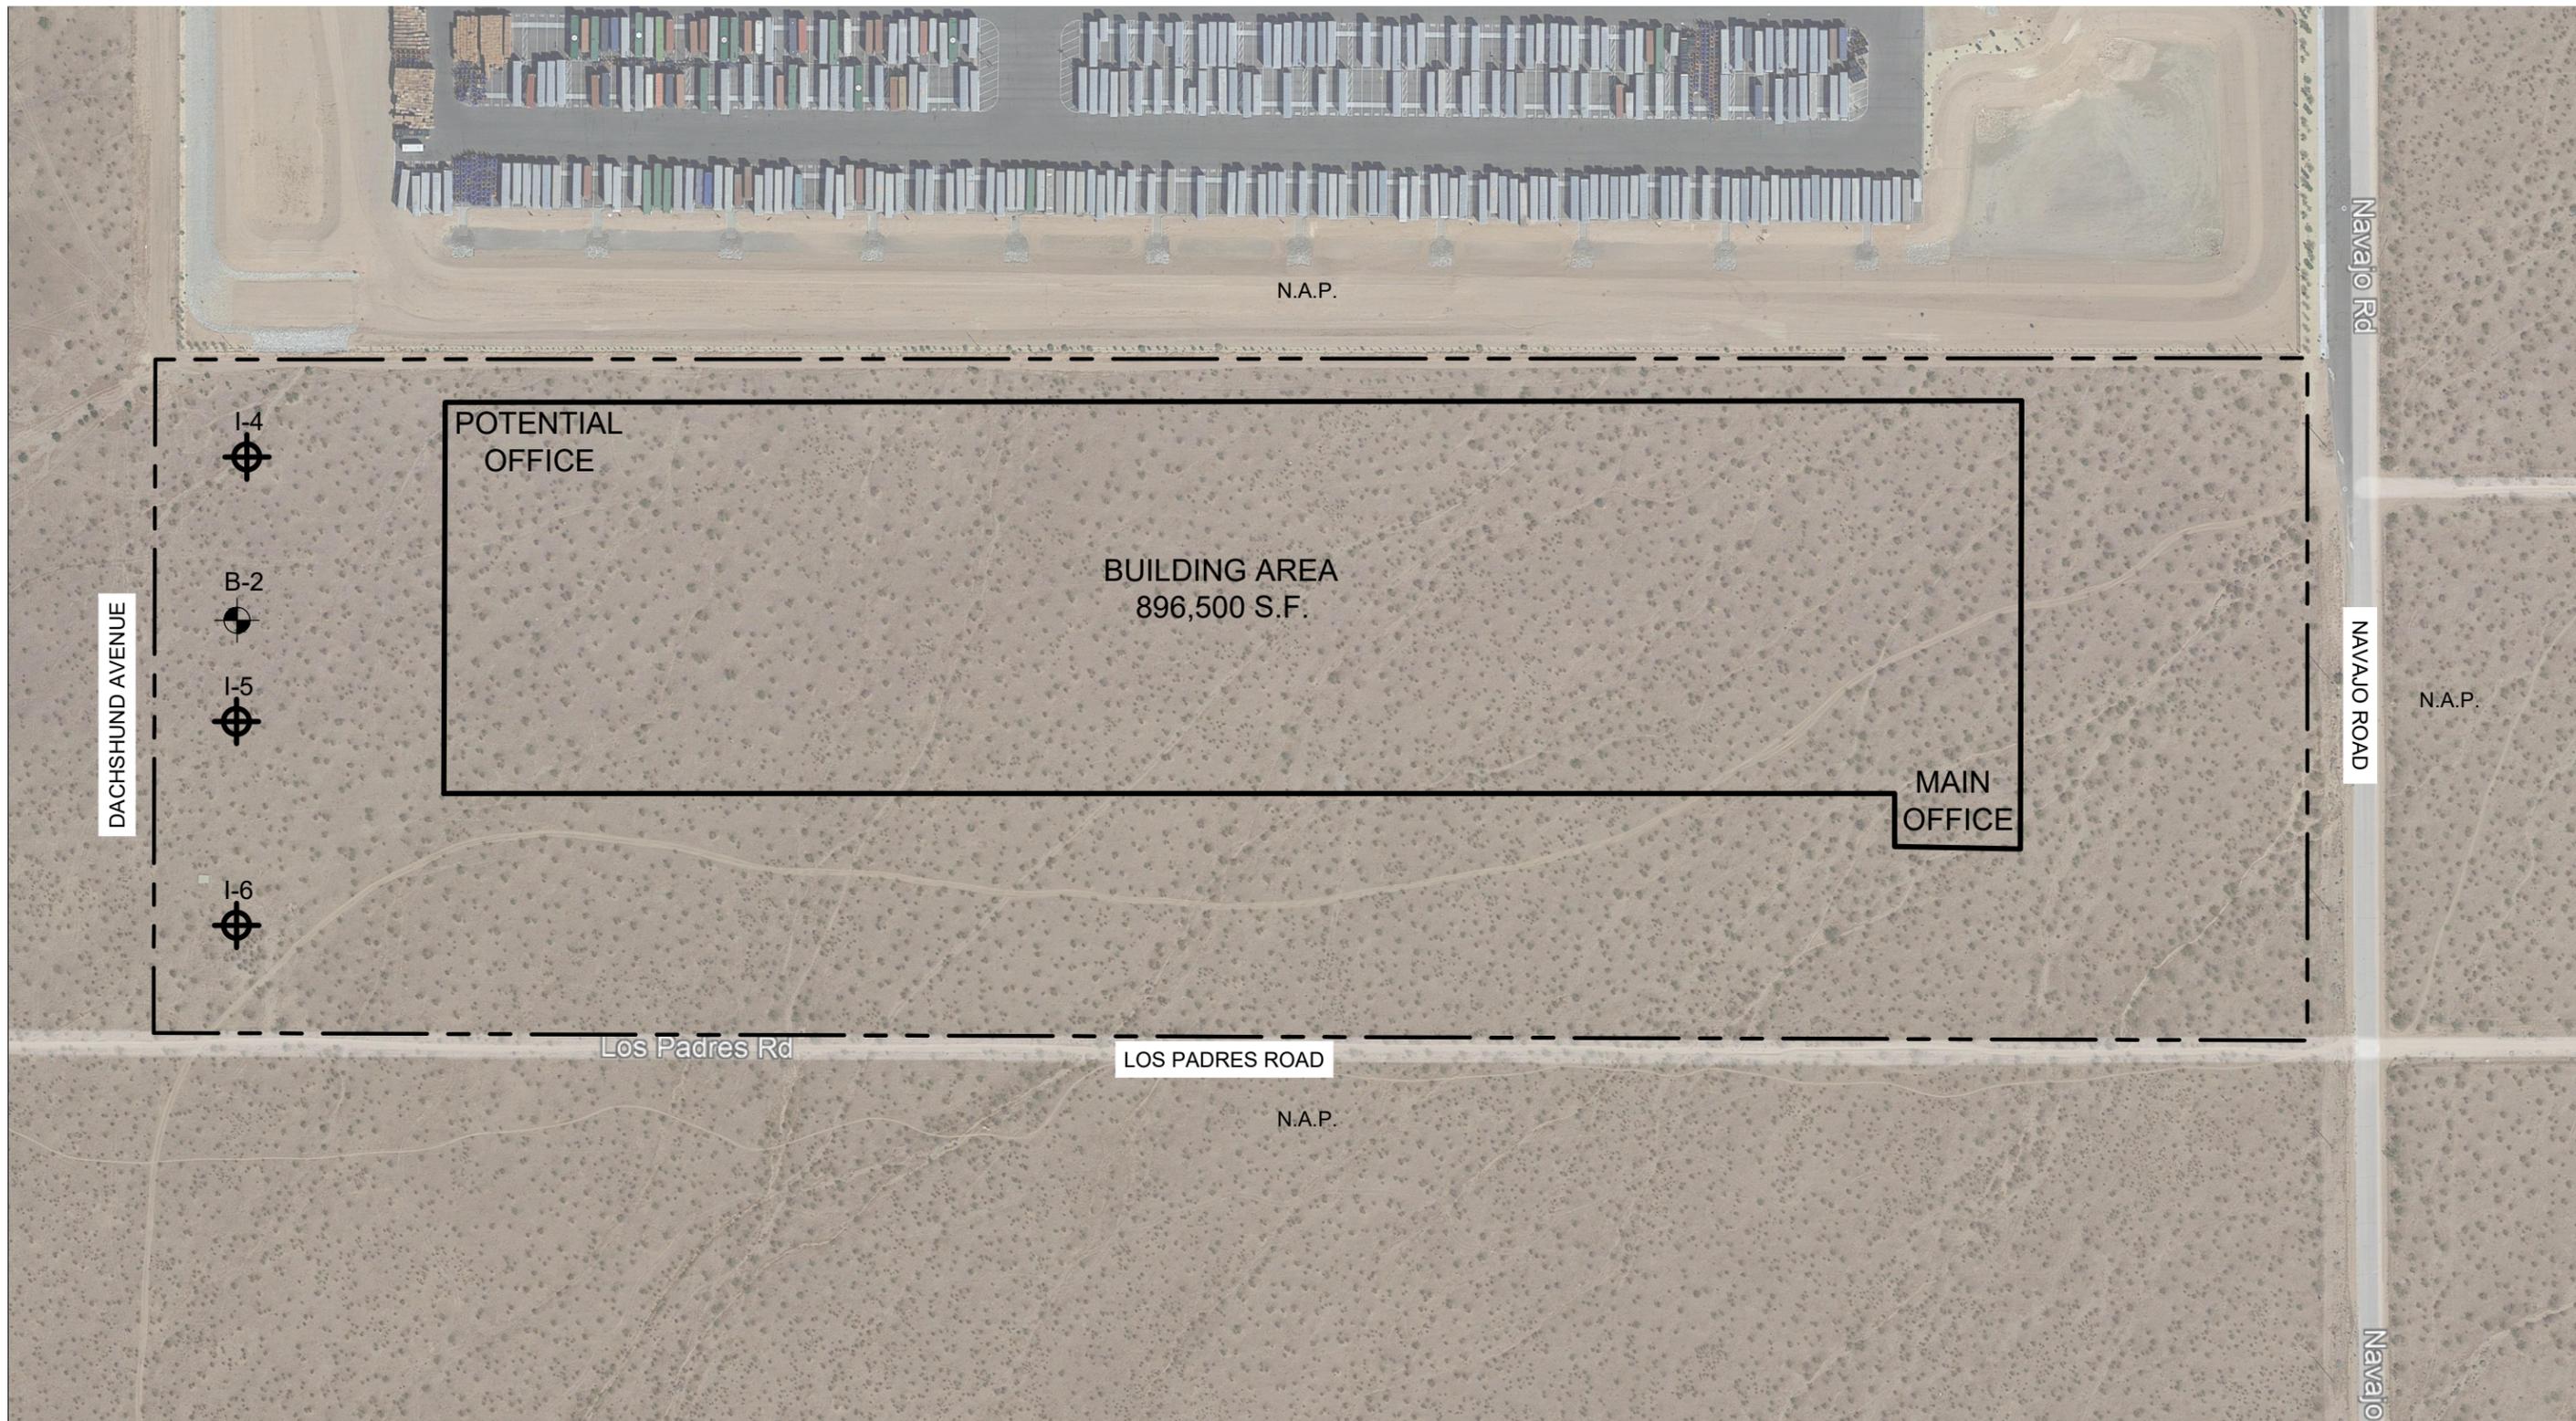
SOUTHERN CALIFORNIA GEOTECHNICAL
DRAWN: MK	
CHKD: DN	
SCG PROJECT 22G197-2	
PLATE 2

APPROXIMATE INFILTRATION TEST LOCATION (SCG PROJECT NO. 22G197-1)
-

APPROXIMATE BORING LOCATION (SCG PROJECT NO. 22G197-1)

NOTE: CONCEPTUAL SITE PLAN PREPARED BY RGA ARCHITECTS.
AERIAL PHOTOGRAPH OBTAINED FROM GOOGLE EARTH.

INFILTRATION TEST LOCATION PLAN	
PROPOSED INDUSTRIAL BUILDING	
APPLE VALLEY, CALIFORNIA	
SCALE: 1" = 200'

The borings were advanced using a truck-mounted drilling rig, equipped with 8-inch-diameter hollow-stem augers and were logged during drilling by a member of our staff. The approximate locations of the infiltration test borings (identified as I-4 through I-6, inclusive) and the exploratory boring (identified as B-2) are indicated on the updated Infiltration Test Location Plan, enclosed as Plate 2 of this report. The Boring Logs are included as an enclosure to this report.

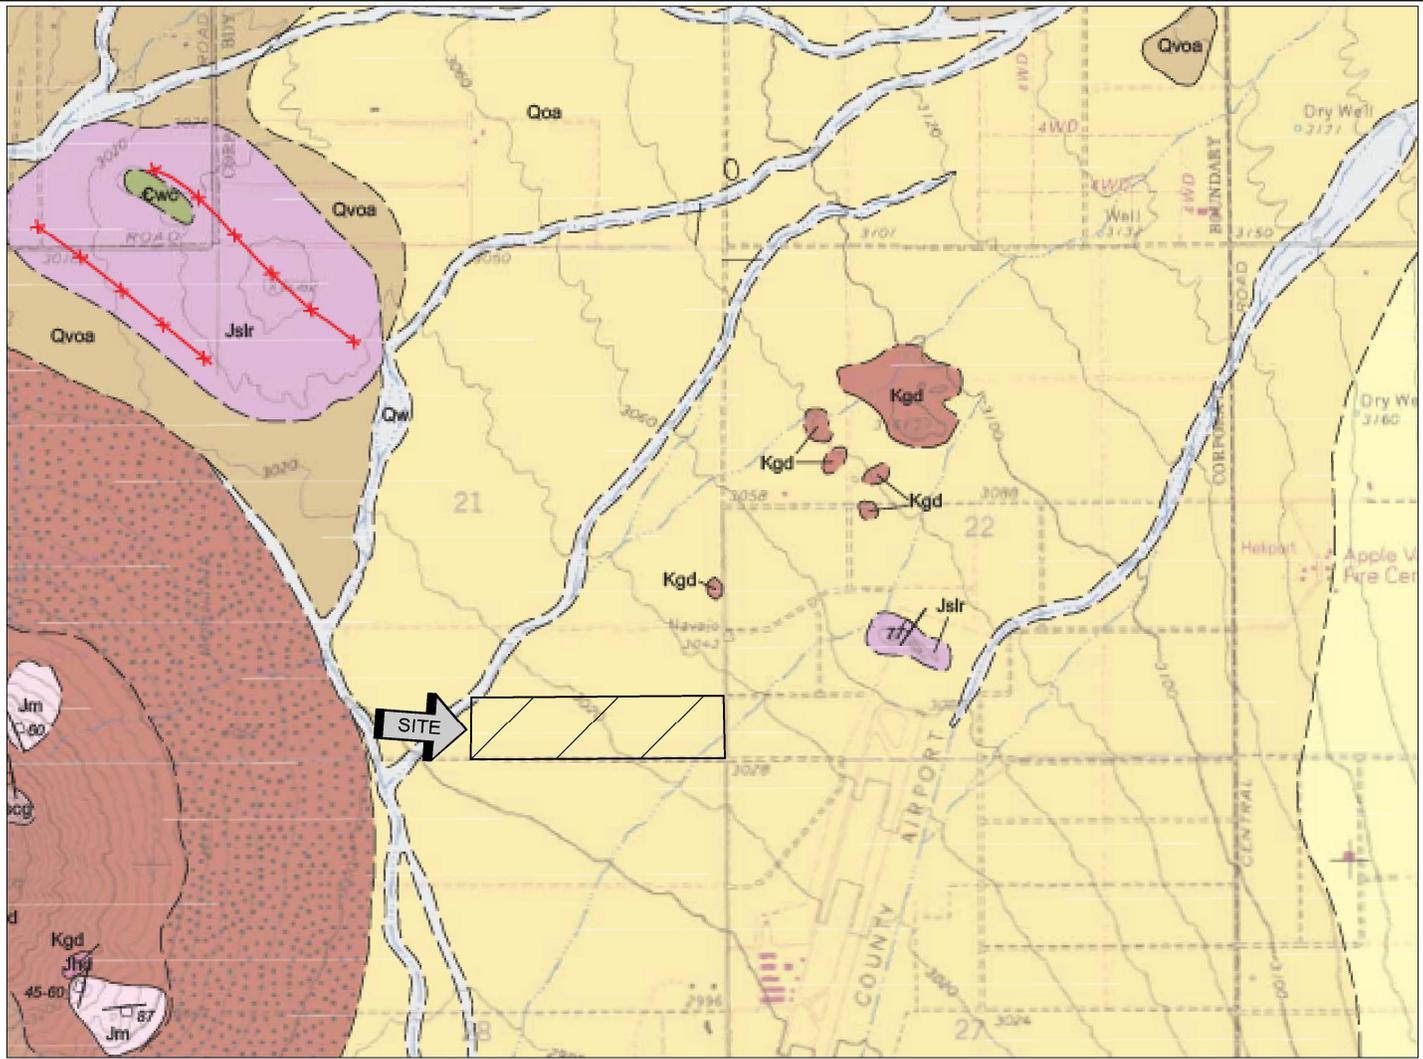
DRAWN: MK	
CHKD: RGT	
SCG PROJECT 22G197-2	
PLATE 3	SOUTHERN CALIFORNIA GEOTECHNICAL

Qw	Wash deposits (late Holocene) – Unconsolidated fine- to coarse-grained sand and fine gravel, very pale-brown (10YR 7/3), angular to sub-angular grains, derived from local bedrock. Subject to localized reworking and new sediment deposition during storm events.
Qoa	Old alluvial deposits (late Pleistocene) – Moderately consolidated brown (7.5YR 4/6) to strong-brown (7.5YR 5/4) fine- to medium-grained sand and fine to medium gravel of inactive alluvial fans. Surfaces are smooth, slightly varnished pavements composed of sand and angular gravel clasts. Gravel clasts range from fine to medium gravel, and consist of slightly metamorphosed sedimentary units of the Fairview Valley Formation, volcanic rocks of the Sidewinder Volcanic series, and minor plutonic clasts. Surfaces are slightly dissected by modern ephemeral minor washes. Soil development includes some clay coatings on sand and gravel clasts and moderate amounts of desert varnish. Minor pinhole porosity in upper few centimeters of soil is common. In the vicinity of Black Mountain, these deposits are mapped as Qia by Stone (2006).

SOURCE: "GEOLOGIC MAP OF THE APPLE VALLEY NORTH 7.5' QUADRANGLE, SAN BERNARDINO COUNTY, CALIFORNIA" BY JANIS L. HERNANDEZ, AND SIANG S. TAN, 2007.

GEOLOGIC MAP	
PROPOSED INDUSTRIAL BUILDING	
APPLE VALLEY, CALIFORNIA	
SCALE: 1" = 2000'

The local geologic conditions of the subject site were determined by research of the Geologic Map of the Apple Valley North 7.5' Quadrangle, San Bernardino, California, compiled by Janis L. Hernandez, and Siang S. Tan, 2007. The map indicates that the majority of the site is underlain by old alluvial deposits (Map Symbol Qoa). This unit is described as late Pleistocene age, medium-grained sand and fine to medium gravel of inactive alluvial fans. The map indicates that a small area in northwest corner of the site may be underlain by gravel wash deposits (Map Symbol Gw) are present in the west portion of the site, as well as the southeast corner of the site. The gravel wash deposits are considered to be late Holocene age, unconsolidated fine to coarse grained sands and fine gravels. A portion of the geologic map is enclosed as Plate 3 of this report.

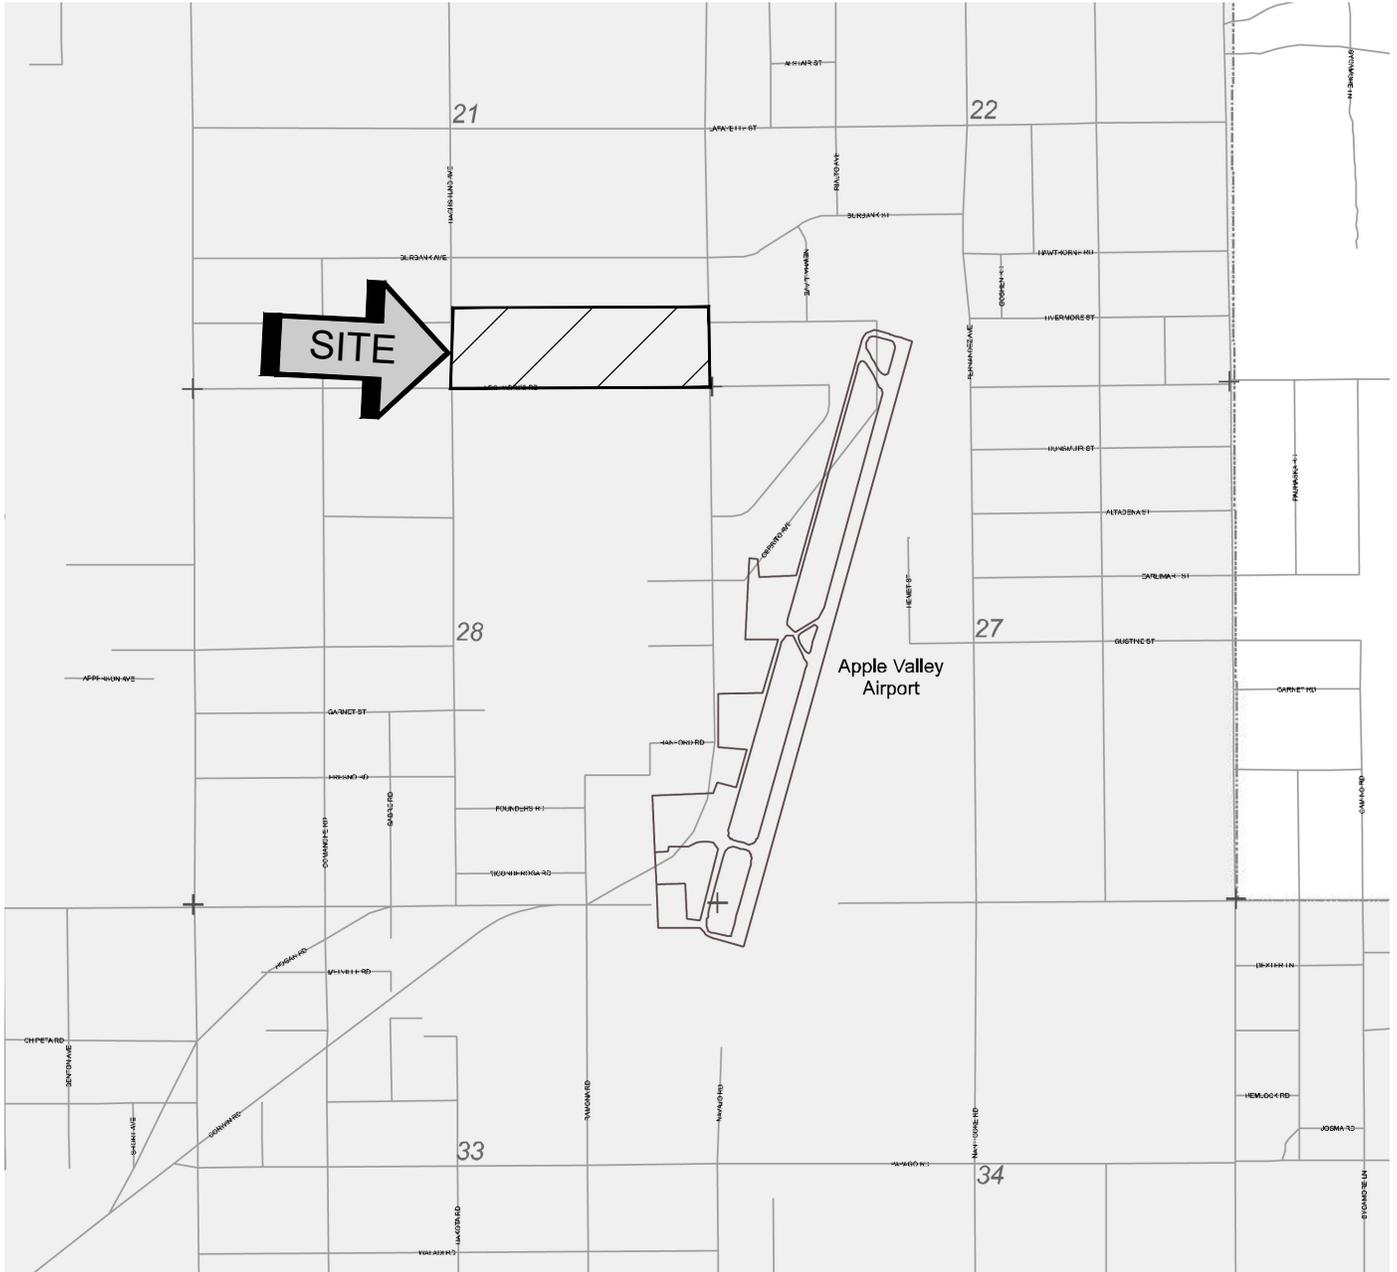
DRAWN: MK CHKD: DN	
SCG PROJECT 22G197-2	
PLATE 4	SOUTHERN CALIFORNIA GEOTECHNICAL

San Bernardino County Land Use Plan GENERAL PLAN Geologic Hazard Overlays

SOURCE: "SAN BERNARDINO COUNTY LAND USE PLAN, GEOLOGIC HAZARD OVERLAYS, APPLE VALLEY NORTH QUADRANGLE" PUBLISHED BY SAN BERNARDINO COUNTY LAND USE SERVICES.

HAZARD MAP	
PROPOSED INDUSTRIAL BUILDING APPLE VALLEY, CALIFORNIA	
SCALE: 1" = 2000'

SCG reviewed the San Bernardino County Land Use Plan Geologic Hazard Overlays for the Apple Valley North Quadrangle, Map EH31 C. A portion of this map is included as Plate 4 of this report. The San Bernardino County Geologic Hazard Overlay maps indicate the locations of designated liquefaction hazard zones, earthquake fault zones, and mapped areas of landslide susceptibility. Based on this map, the site is not located in any county of San Bernardino designated liquefaction hazard zones, earthquake fault zones, nor in any earthquake-induced landslide hazard zones.
